# Manhole Inspection Summary

Manhole # S67Q\_\_007MH

**Location** Address: **1500 Block of Cardiff St.** Cross Street: **Stromeyer Way**

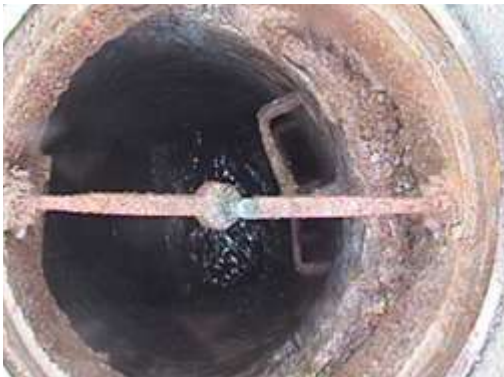
Defect 1

**Frame** Offset: **3** (in.) Condition: ☒ Sound ☐ Cracked ☐ Leaks

Offset frame 3".

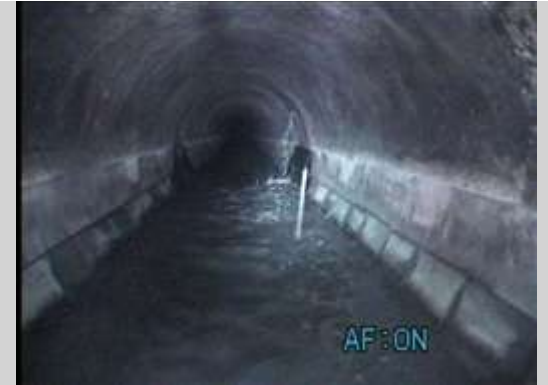
12 O'Clock Outflow

54 in. Circular Gravity Sewer  
Pipe Out @ 12 O'Clock

Pipe Height: **56.4** (in.) Rod and Bar (Angled)  
Pipe Material: **Concrete** ☐ Pipe Lined  
Invert Depth: **19.33** (ft.) Flow Characteristics: **Fast**  
Deposits: ☒ None ☐ Mud ☐ Gravy ☐ Debris ☐ Grease  
Silt Depth: (in.) Deposits Extent:  
Infiltration: **None** Pipe Seal Cond: **Sound**

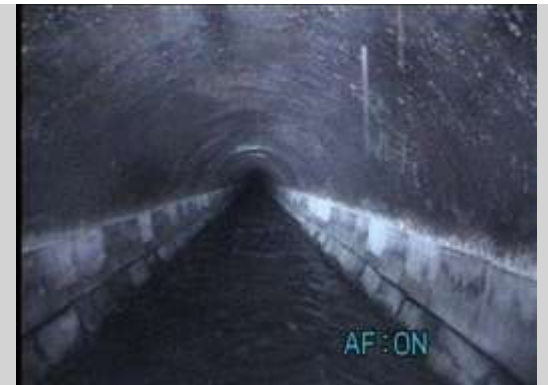
6 O'Clock Inflow

54 in. Circular Gravity Sewer  
Pipe In @ 6 O'Clock

Lines in picture are rain falling down thru manhole.

Pipe Height: **56.4** (in.) Rod and Bar (Angled)  
Pipe Material: **Concrete** ☐ Pipe Lined  
Invert Depth: **19.25** (ft.) Flow Characteristics: **Fast**  
Deposits: ☒ None ☐ Mud ☐ Gravy ☐ Debris ☐ Grease  
Silt Depth: (in.) Deposits Extent:  
Infiltration: **None** Pipe Seal Cond: **Sound**

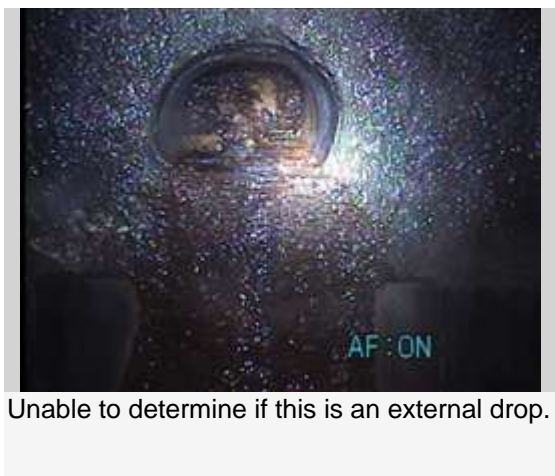
9 O'Clock Inflow

8 in. Circular Gravity Sewer  
Pipe In @ 9 O'Clock

Pipe Height: **8.4** (in.) Rod and Bar (Angled)  
Pipe Material: **Clay** ☐ Pipe Lined  
Invert Depth: **16.83** (ft.) Flow Characteristics: **None**  
Deposits: ☐ None ☐ Mud ☒ **Sludge** ☐ Debris ☐ Grease  
Silt Depth: **1** (in.) Deposits Extent: **Heavy**  
Infiltration: **None** Pipe Seal Cond: **Sound**
